September 14, 1942

SERVICE LETTER A-11

Subject: Periodic Inspection of Crankshafts on Warner Scarab
125 H.P. Engines.

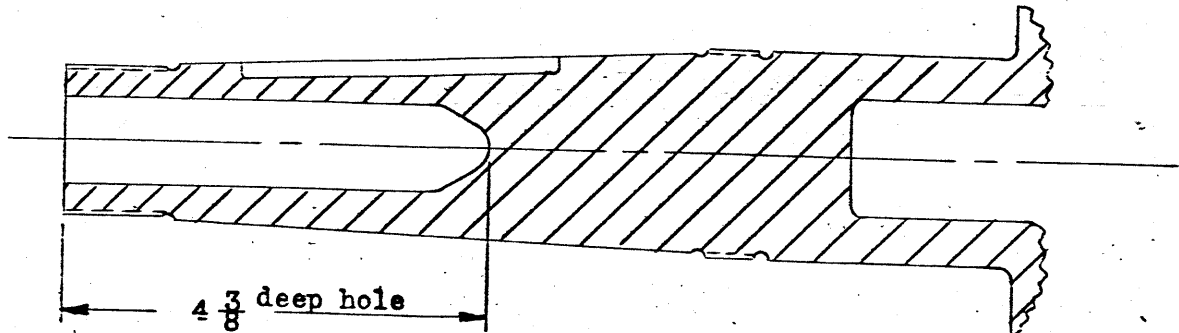
SKETCH No. 1

1. Check which type of crankshaft is used in your engine. If the shaft has a $4\frac{3}{8}$ " deep hole in the front end of the crankshaft as indicated in Sketch No. 1 below, then the contents of this service order are not applicable to the engine and no 50 hour inspection of the shaft is required. It may be advisable to occasionally take off the propeller and check for galling and to relap the hub on the shaft as outlined below in paragraph 10 if the shaft is found galled.

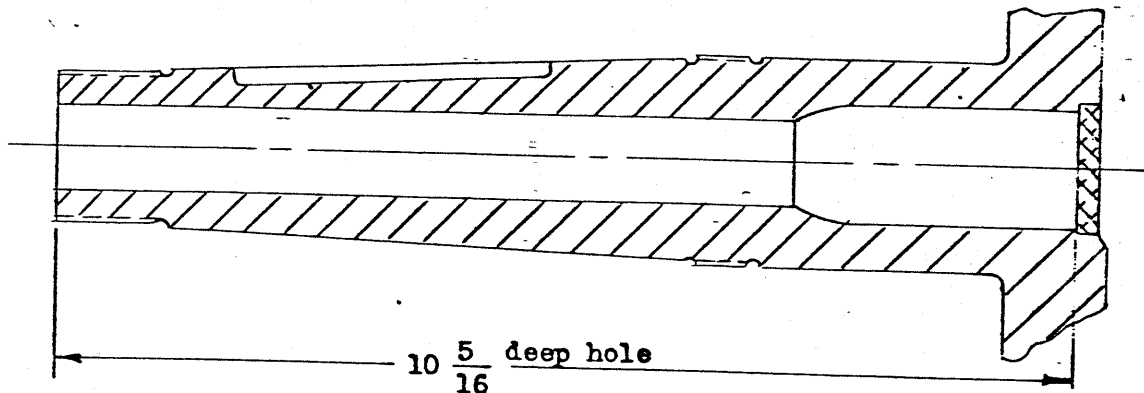
SKETCH No. 2

2. If the shaft has a $10\frac{5}{16}$ " deep hole as shown in Sketch No. 2, the instructions of this service letter are applicable and must be carried out.

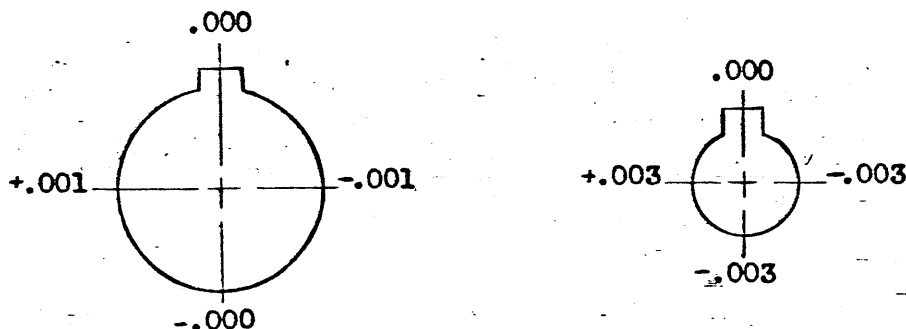
(d) If your airplane has been involved in an accident which may have bent the crankshaft, it should be checked with a dial indicator at the small and large ends of the taper. For this purpose a dial indicator should be mounted on a rod which is securely fastened to a thrust bearing cover attaching stud. For a crankshaft checked without ball bearings on a surface plate, the allowable runout at the small end is .004" if the checking procedure outlined on page 21 of the third edition of the Warner Engine Handbook is followed. When the engine is installed in the airplane slightly higher readings may be observed due to the eccentricity limits of the ball bearings. When in doubt, make a rough sketch of the indicator readings obtained at the large and small ends of the taper in relation to the keyway as seen from the front and submit it to the Warner Aircraft Corporation for comments. To clarify this matter, a sample sketch is shown:

At no time should a crankshaft, which is found to be bent, be straightened.
