January 1, 1943

SERVICE LETTER NO. A-12.

Subject: Valve - Carburetor Heat Control Assembly No. 8290 - Modification of Linkage.

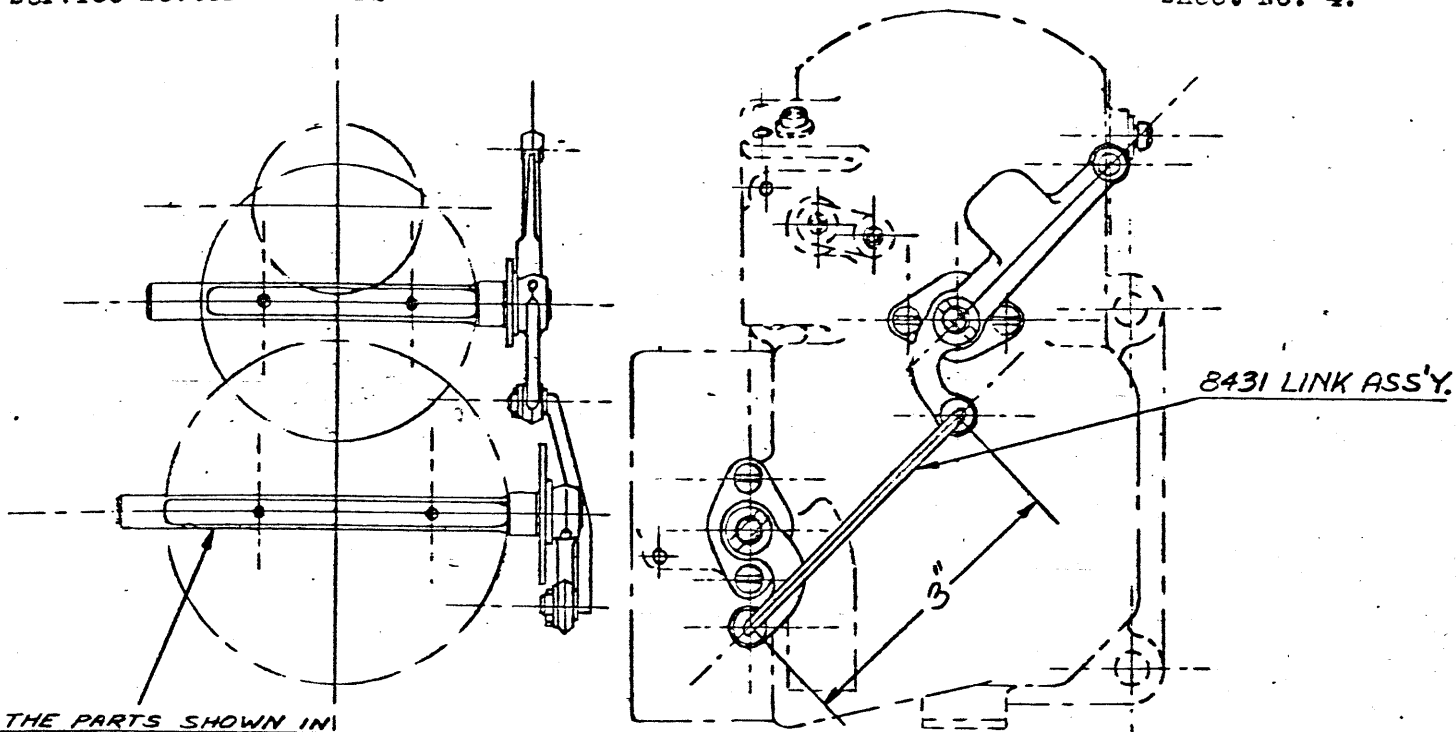
Figure 1-

Originally the No. 8290 Heater Valve Assembly was equipped with the linkage as shown in Figure 1 below. Part No. 8645 has been assigned to this linkage. This part number includes all parts shown in full, namely the two shafts with the levers and retainers attached to them and the link assembly.

- (a) The link assembly between the two levers in the old linkage was assembled from the bottom. Whenever the cotter pins retaining this rod would wear through due to vibration, the rod would drop off which may result in both the hot and cold valves closing causing a forced stop of the engine.

- (b) In the old linkage, the two levers were a reamed fit on the shafts and were retained by two taper pins. Vibrations had a tendency to permit the levers to become loose on the shaft. To eliminate this condition, on the latest linkage the shafts are silver soldered into the levers in addition to being pinned.

Due to the present system of priorities, it will be difficult in many cases to replace the old linkage with a new linkage. It is, therefore, recommended that whenever the levers are found loose on the respective shafts, the shafts and levers be removed from the valve assembly after making an inspection to find out whether the bushings which are pressed into the housing have worn excessively and need to be replaced.

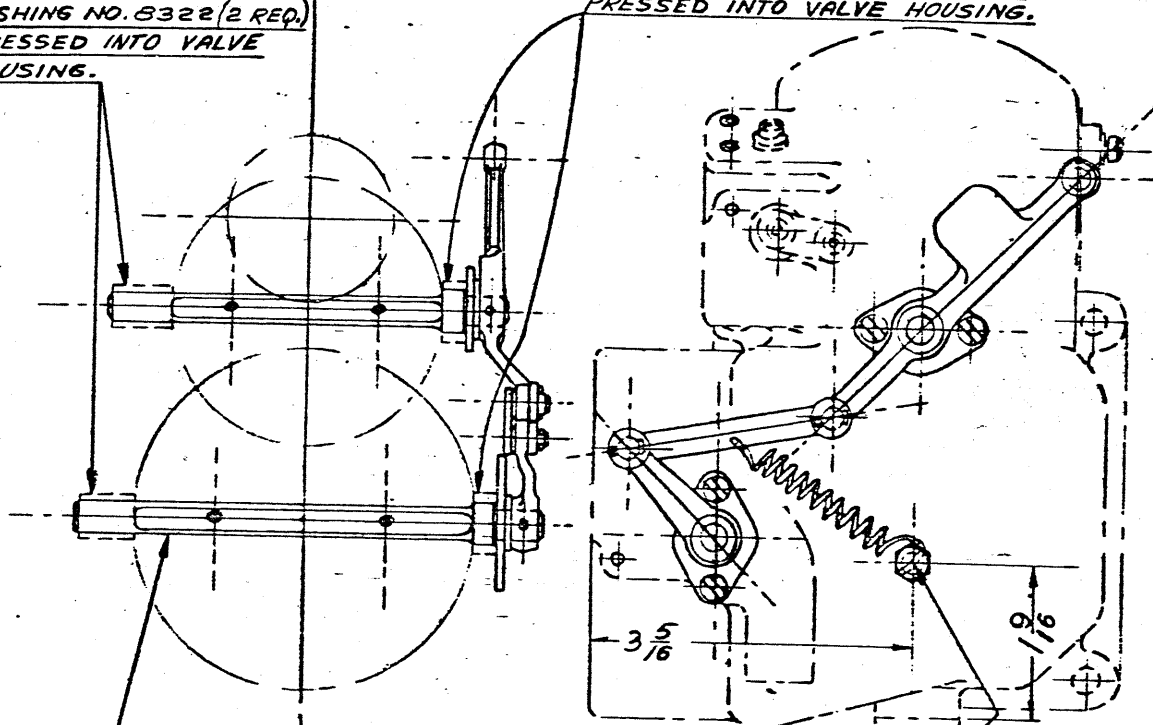
Figure 2-

The latest No. 8290 Heater Valve, No. 8290, Ch. "E", is equipped with the linkage as shown below in Figure 2. Assembly No. 8646 has been assigned to the linkage shown in Figure 2 which includes the shafts to which the levers shown are attached, the link assembly, and also the spring and spring anchor screw.

- (c) A spring has been added to the linkage which serves two purposes. In case of a failure of the control between the heater valve and the cockpit, the spring moves both the cold and hot butterfly valves into a half-open position so that such a failure does not cause a forced stop of the engine. Secondly, this spring maintains a constant load on the lever and connecting link, thereby eliminating wear due to vibration.

- (a) If it should be desired to install the new 8646 linkage in lieu of the old linkage, the entire new linkage assembly, as shown in Figure 2 in solid lines, including the spring and spring anchor bolt, can be ordered from The Warner Aircraft Corporation under the part No. 8646. This assembly number does not include the 8322 and 8311 bushings described above under "Repair of Old Linkage". These bushings must be ordered separately if their replacement is found necessary.
- (b) After the old linkage has been removed, as described above under "Repair of Old Linkage", the 13/64" diameter hole for the spring anchor bolt, as shown in Figures 2 and 2A, must be drilled and the anchor bolt installed as shown in Figure 2A.

WHEN INSTALLING THIS LINKAGE DRILL 3/8 DIA. HOLE IN HOUSING NR 8291 IF NOT ALREADY DRILLED.
