THE WARNER AIRCRAFT CORPORATION  
20283 HOOVER AVENUE  
DETROIT 5, MICH.

SERVICE LETTER A-15

**Subject:** Cylinder Attaching Studs - Proper Maintenance,  
Inspection and Assembly Procedure

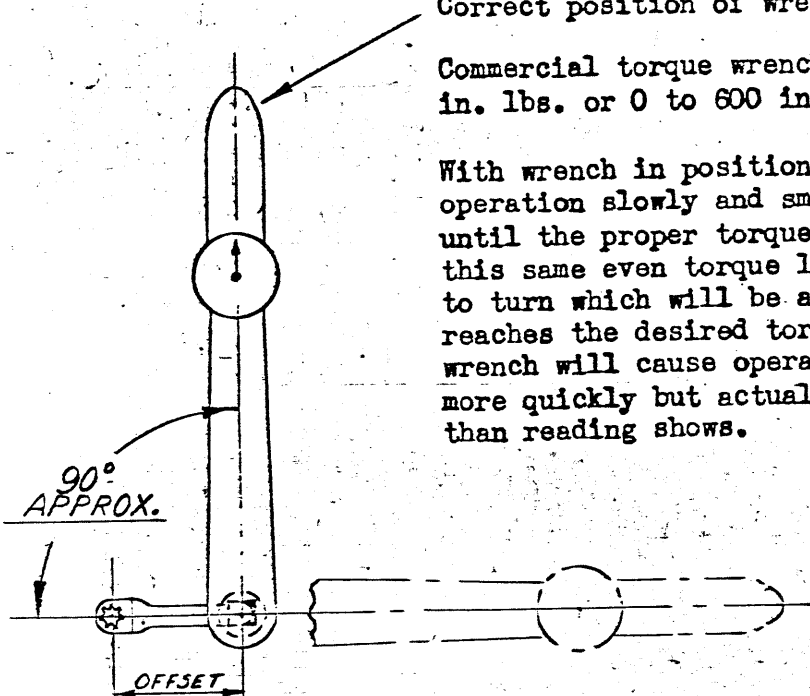
FIGURE 1

Correct position of wrench (90° to offset).

With wrench in position shown perform the tightening operation slowly and smoothly without interruption until the proper torque has been applied. Maintain this same even torque load until the part has ceased to turn which will be a few seconds after indicator reaches the desired torque reading. Jerking of the wrench will cause operator to reach the torque reading more quickly but actual torque applied will be less than reading shows.

Wrong position of wrench (in line with offset)

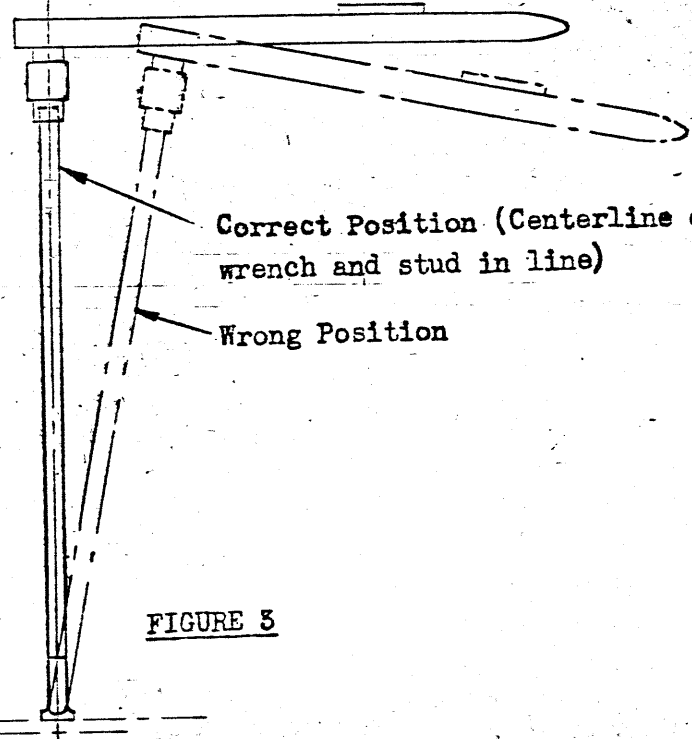
FIGURE 3

Correct Position (Centerline of wrench and stud in line)

Wrong Position
