THE WARNER AIRCRAFT CORPORATION  
20263 Hoover Avenue  
Detroit 5, Michigan

SERVICE LETTER NO. A-17

Subject: I. Replacement of S-506 Cylinder Hold-Down Stud and Nut N-511 with S-911 Stud and N-910 Nut.  
II. Replacement of Gasket between Cylinder Barrel and Crankcase with an "O" Type Ring.

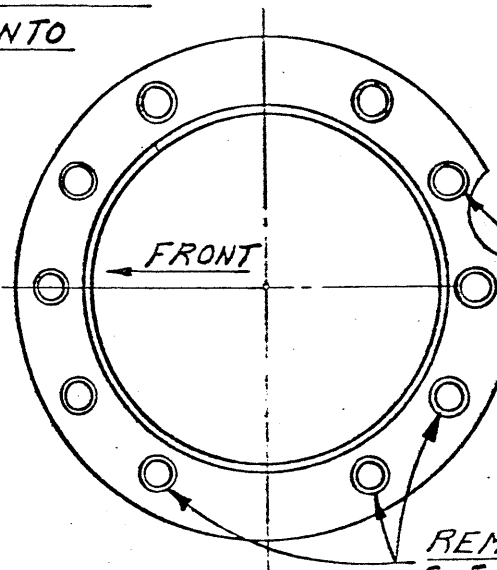
FIG. -1

$\frac{1}{8}$  DIA. C'SINK  
INDICATES STUD  
END TO BE SET INTO  
C'CASE.

- (5) Due to the fact that both ends of the replacement stud have a  $3/8$  - 24 thread with the exception of the S-506 + .062 and S-776 + .062 which have a  $7/16$  - 20 thread, the stud end or the end which must be screwed into the crankcase has been identified with a  $1/8$ " diameter countersink in the center of the stud end as shown in Figure 2. Extreme care must be exercised to insure the countersunk end of the stud is screwed into the aluminum, and after the studs are installed, an inspection should be made of the protruding ends of all of the studs to make certain that no countersink appears on them.

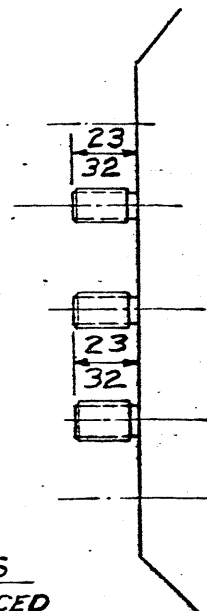
FIG. -3

- (6) After the proper studs have been selected, they should be set into the crankcase with a minimum torque of 50 inch pounds and a maximum torque of 275 inch pounds. If the torque exceeds this maximum, the pitch diameter may be reduced by etching as outlined in Service Letter A-15 or the pitch diameter of the tapped hole may be increased by the use of an oversize pitch diameter tap. All studs must be set to a height of  $23/32$  from the face of the crankcase as shown in Figure #3.

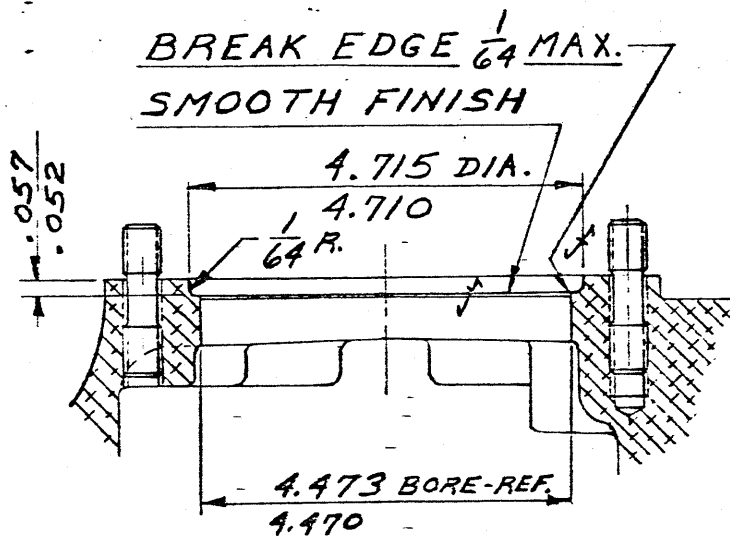
FIG. - 4

DIMENSIONS OF C'BORE  
TO BE CUT ON WARNER

4  $\frac{1}{4}$  BORE ENGINES.

FOR USE WITH 4  $\frac{1}{4}$  I.D. X  $\frac{1}{16}$

"O" RING-WARNER PART #11195.

- (1) To modify the crankcase for use with an "C" type ring, it is necessary that the crankcase be assembled on the bench with the crankcase bolts sufficiently tight to line up the front and rear halves of the crankcase and hold them tightly together. A hand-operated counterboring tool, Warner Part #FA-11127 is available for sale to authorized service stations to modify Warner Engines, Models Scarab Jr. and Scarab, in service for use with "C" Ring #11195 as shown in Figure No. 4. Counterboring tool,

- (2) While the crankcase remachined in service will have counterbores as shown in Figures 4 and 5, crankcases received from the factory may have countersinks instead. In either case, however, the "O" rings specified will fit properly.

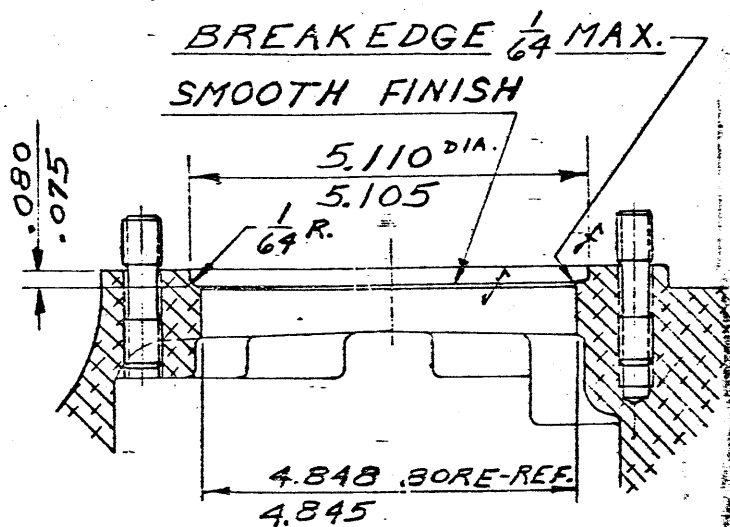
FIG. -5

DIMENSIONS OF C'BORE  
TO BE CUT ON WARNER

4  $\frac{5}{8}$  BORE ENGINE.

FOR USE WITH 4  $\frac{5}{8}$  I.D. BY  $\frac{3}{32}$

"O" RING-WARNER PART #8566.

Warner Part #FA-11177 is also available for modifying other Warner Engines, Models Super-Scarab Ser. 40, 50, and 50A and Model 165 in service for use with "O" Ring #8566, Figure No. 5.
