Service Letter A-7

Service Memorandum to owners of airplanes powered by Warner Super-Scarab 145  
HP engines.

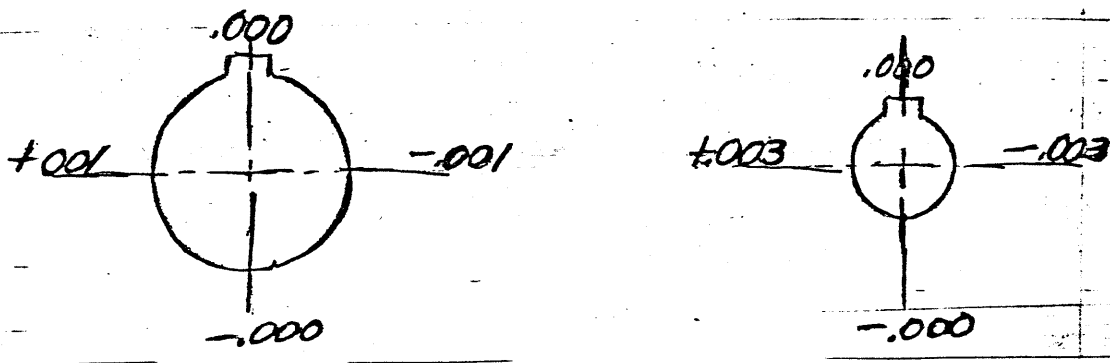
- d) If your airplane has been involved in an accident which may have bent the crankshaft, it should be checked with a dial indicator at the small and large ends of the taper. For this purpose a dial indicator should be mounted on a rod which is securely fastened to a thrust bearing cover attaching stud. For a crankshaft checked without ball bearings on a surface plate, the allowable runout at the small end is .004" if the checking procedure outlined on page 21 of the third edition of the Warner Engine handbook is followed. When the engine is installed in the airplane slightly higher readings may be observed due to the eccentricity limits of the ball bearings. When in doubt, make a rough sketch of the large and small ends of the taper in relation to the keyway as seen from the front and submit it to the Warner Aircraft Corp. for comments. To clarify this matter, a sample sketch is shown below:

At no time should a crankshaft, which is found to be bent, be straightened.
