THE WARNER AIRCRAFT CORPORATION

SERVICE LETTER NO. A-9

Subject: Replacement of Link Rod Bolts.

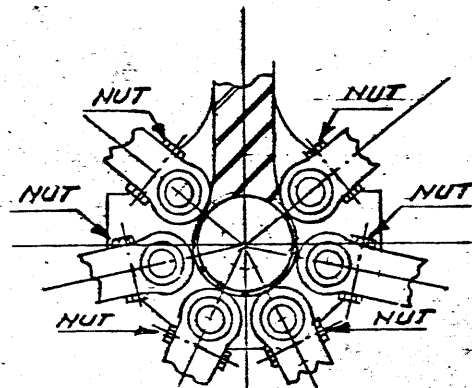
FIG. 1 FULL SIZE

We have found it advisable to bring out a new link rod bolt--part No. 7072-B. This bolt is considerably stronger than the old bolts and, in addition, the section locking the wrist pin is surface-hardened so as to eliminate wear. It can be distinguished from the older bolts by the length of the undercuts and of the center section as shown on Figure 1 below. The following engines were equipped at the factory with 7072-B bolts and are not affected by this Service Letter: 145 H.P. Super Scarab engine No. SS-733 and up and 165 H.P. Super Scarab engine No. SS-2024 and up.

Some recent engines are equipped with bolt No. 7072-A which can be recognized by the $\frac{1}{4}$ " long undercuts next to the head and next to the thread and by the center section being approximately $\frac{29}{64}$ " long. These bolts do not have the center section hardened and are installed in 145 H.P. Super Scarab engines No. SS-708E and SS-717E to SS-732E. They are not installed in any Model 165 engine. These bolts need only be changed if they show wear on the center section.
