THE WARNER AIRCRAFT CORPORATION  
20263 Hoover Avenue  
Detroit 5, Michigan

SERVICE LETTER A-16

**Subject:** Carburetor Heat Control Valve Assembly No. 7720 and 7989 -  
Drilling of Drain Hole to Eliminate Fire Hazards

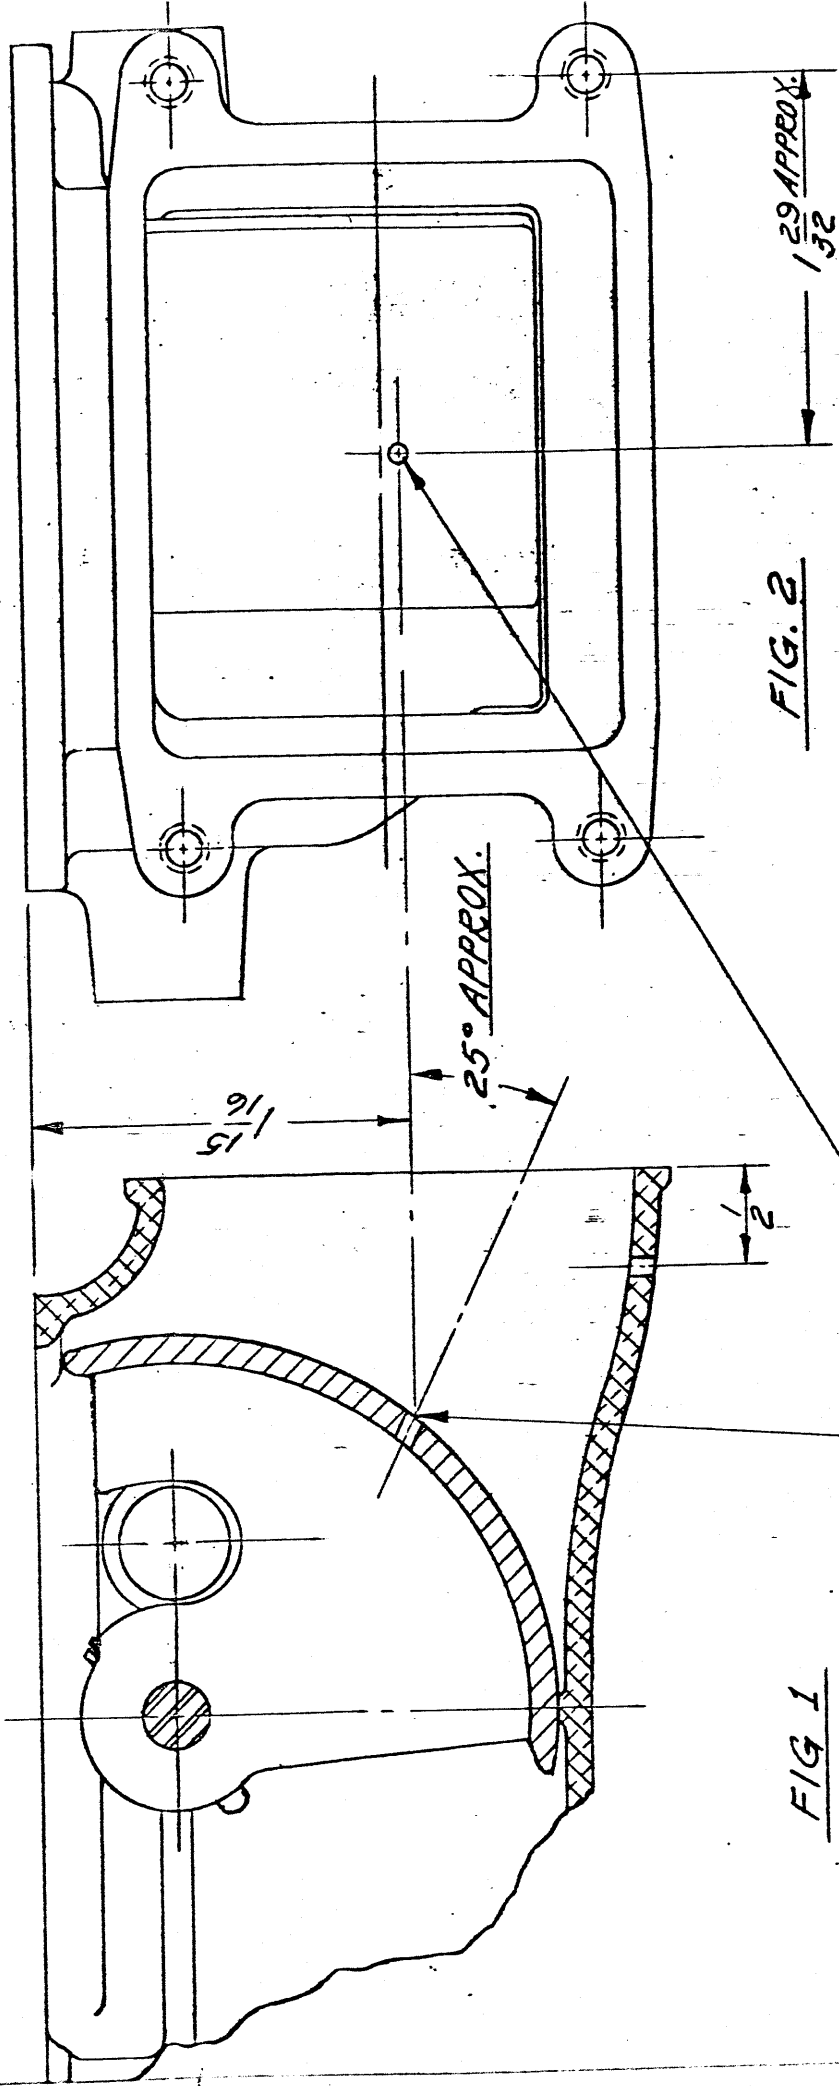
1. In order to eliminate the fire hazards from fuel collecting in the cup shaped valve of the No. 7720 and 7989 Heat Control Valve Assembly, when the valve is in the midway position, a drain hole must be drilled in the valve as soon as possible as indicated in Figure 1 and 2 of this Service Letter. The drilling of the 3/32" diameter drain hole may readily be accomplished by removing the Carburetor Heat Control Valve Assembly from the engine. It is not necessary nor desirable to disassemble the units further for this operation, but it is important that all burrs be removed from the edges of the drilled hole and all chips carefully washed out before the heat control valve is reassembled to the engine.

2. Care must be exercised that the control valve is in the position shown in Figure 1 in which the rear or hot air opening is completely closed when the hole is being laid out and drilled. When these instructions are carried out, the drain hole is at the lowest point when the control valve is in the half-way position.
